Survey No. M: 19-35

Maryland Historical Trust State Historic Sites Inventory Form

1. Nam	e (indicate preferred name)		
historic			
and/or common	Wesley Hargett Farm		
2. Loca	tion	appropriate the following of the con-	
street & number	13931 Schaeffer Road		_ not for publication
city, town	Germantown X vicinity of	congressional district	New York (1994) Section (1994)
state	Maryland cou	nty Montgomery

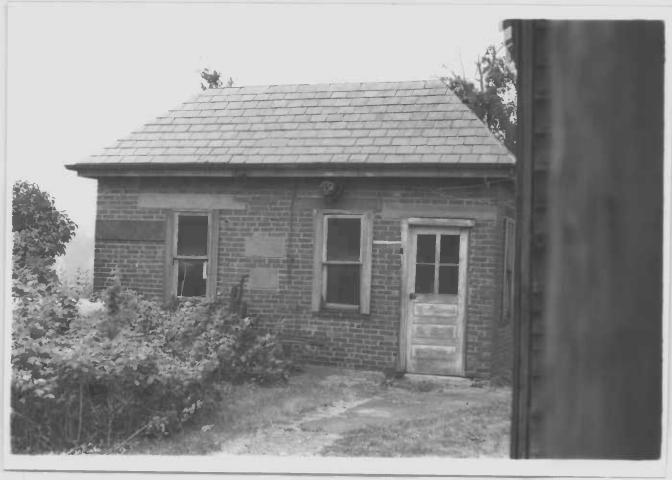
M:19-35

The dairy to the southeast of the barn was built c. 1930, and is a small, three bay by one bay brick structure with a slate covered hip roof. Over the door and windows are large stone lintels. Three other pieces of stone are inserted in the southeast (front) elevation. The windows have one-over-one wood sash. The upper half of the wood door contains four lights, the lower half contains three horizontal, raised panels.

Wesley Hargett Farm
13931 Schaeffer Road
Germantown, MD
Andrea Rebeck 1987
Dairy, southeast elevation

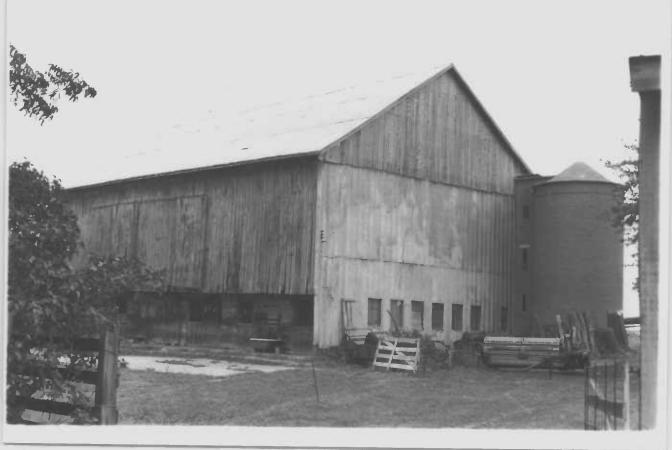
M: 19-35

Wesley Hargett Farm
13931 Schaeffer Road
Germantown, MD
Andrea Rebeck
1987
Looking west
